Home Inspection Report

5 Key West Dr, Danbury , CT 06811

Inspection Date:

Tuesday September 29, 2015

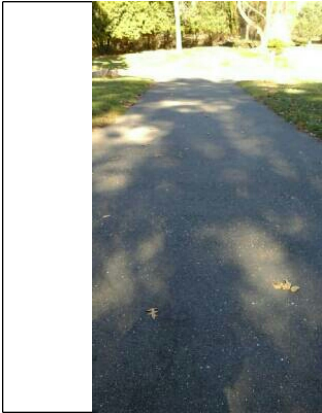
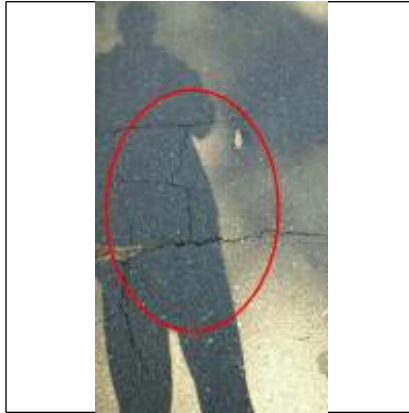
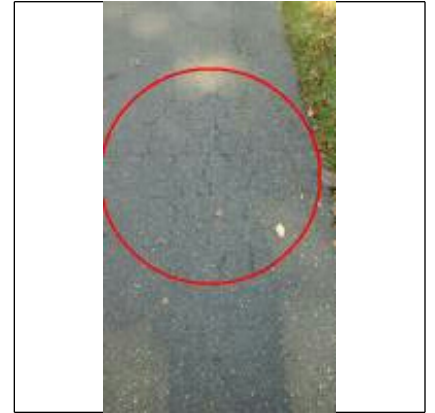
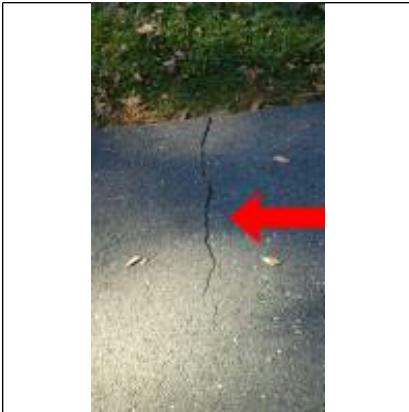
Comments Few cracks Driveway had some settlement, but usable, recommend repair

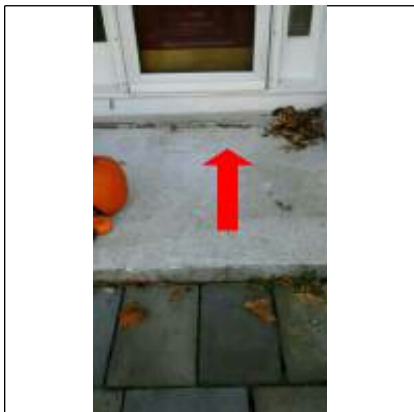
Comments Sound service, but pitches towards house.

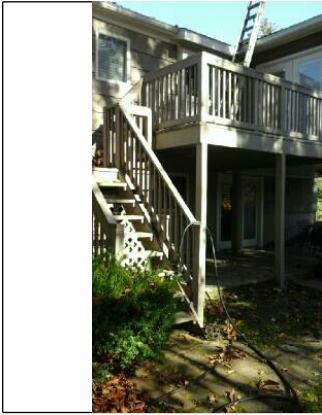
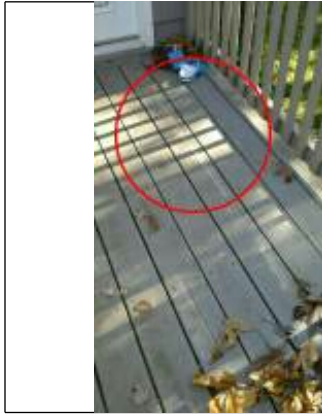
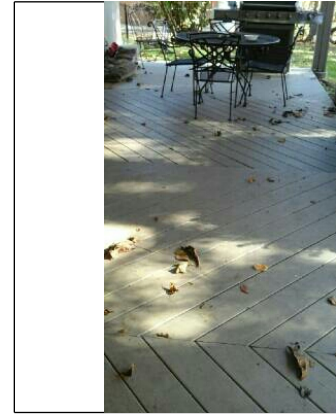
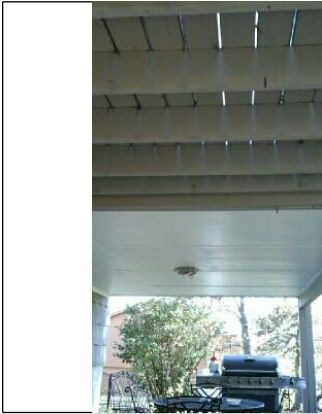
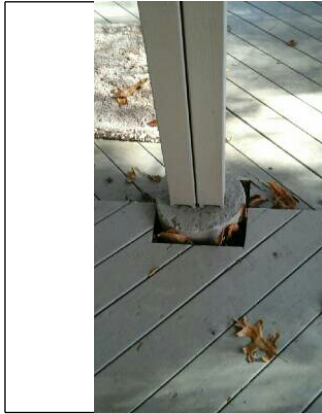
Comments Needs paint or stain on floor.

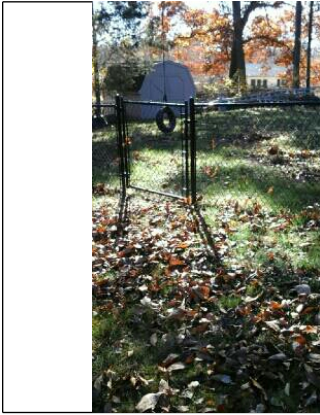
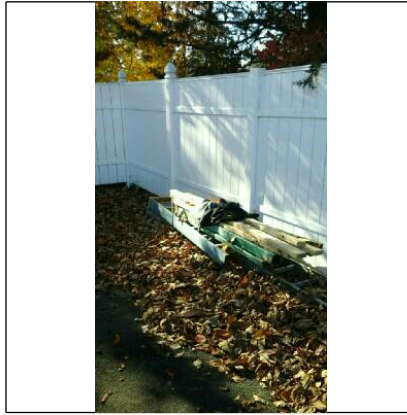
Comments Plastic fence missing post cover.

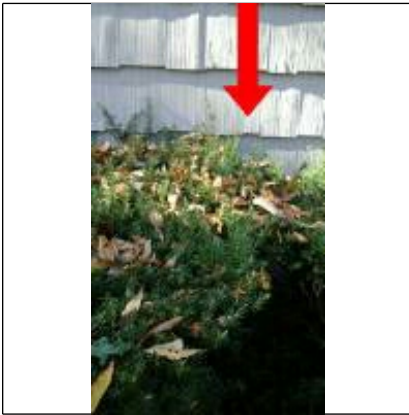
Comments Shrubs close to house.

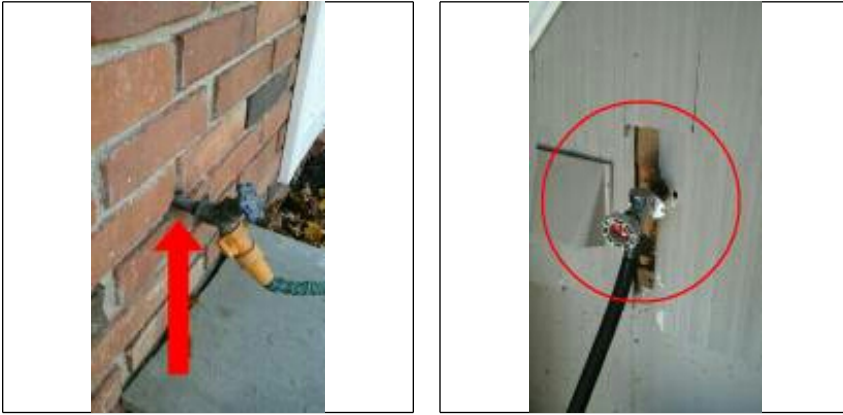
Comments Back hose bibb missing siding around it.
 Front hose bibb not freeze proof and not secured to house.

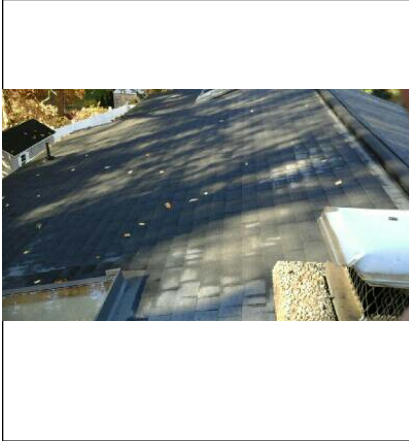
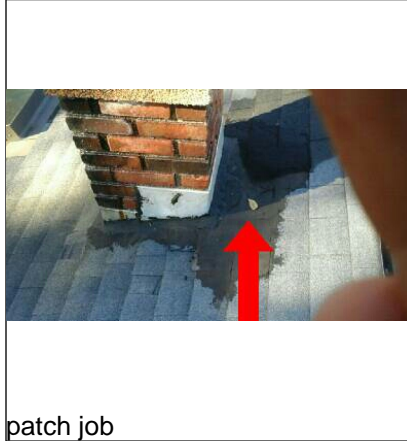
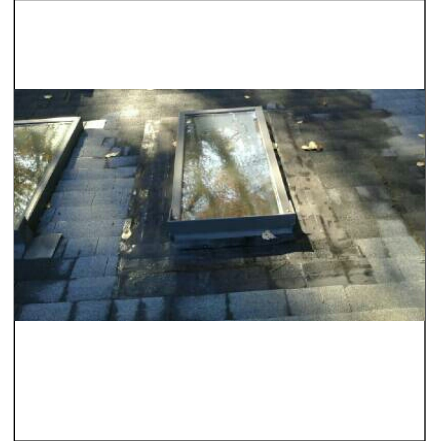
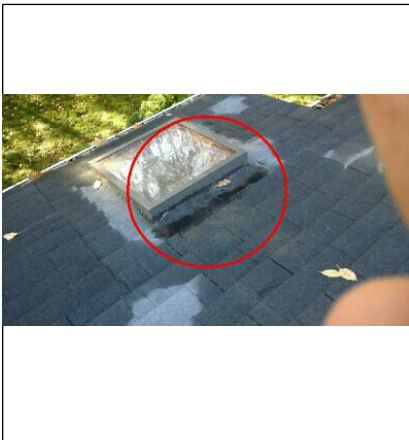
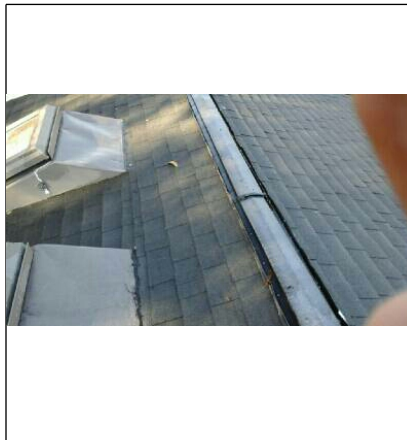
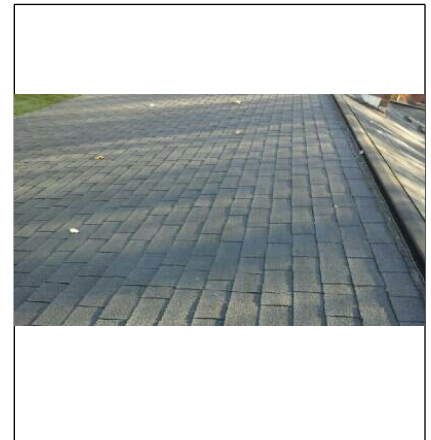
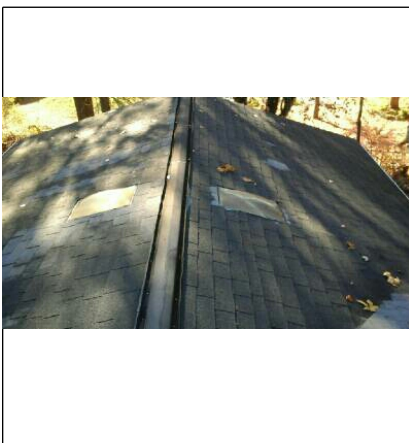
Roof is patched around chimney and skylights and missing shakes. Will need a new roof in the near future.

Roof #1 ☐ Satisfactory ☒ Marginal ☐ Poor ☐ Curling ☐ Cracking ☐ Ponding ☐ Burn Spots
☒ Broken/Loose Tiles/Shingles ☐ Nail popping ☒ Granules missing ☐ Alligating ☐ Blistering
☒ Missing Tabs/Shingles/Tiles ☐ Moss buildup ☐ Exposed felt ☐ Cupping
☐ Incomplete/Improper Nailing ☒ Recommend roofer evaluate ☐ Evidence of Leakage
Roof #2 ☐ N/A ☐ Satisfactory ☐ Marginal ☐ Poor ☐ Curling ☐ Cracking ☐ Ponding ☐ Burn Spots
☐ Broken/Loose Tiles/Shingles ☐ Nail popping ☐ Granules missing ☐ Alligating ☐ Blistering
☐ Missing Tabs/Shingles/Tiles ☐ Moss buildup ☐ Exposed felt ☐ Cupping
☐ Incomplete/Improper Nailing ☐ Recommend roofer evaluate ☐ Evidence of Leakage
Roof #3 ☐ N/A ☐ Satisfactory ☐ Marginal ☐ Poor ☐ Curling ☐ Cracking ☐ Ponding ☐ Burn Spots
☐ Broken/Loose Tiles/Shingles ☐ Nail popping ☐ Granules missing ☐ Alligating ☐ Blistering
☐ Missing Tabs/Shingles/Tiles ☐ Moss buildup ☐ Exposed felt ☐ Cupping
☐ Incomplete/Improper Nailing ☐ Recommend roofer evaluate ☐ Evidence of Leakage

Roof appeared to be nearing end of its useful life, budget to replace soon.

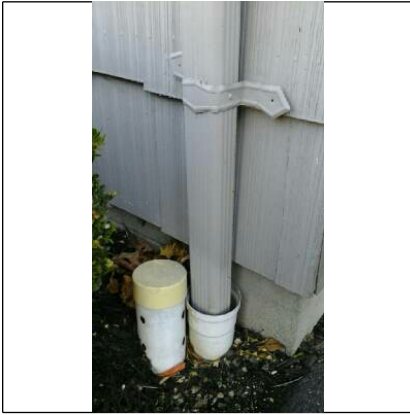
Leaking ☐ Corners ☒ Joints ☐ Hole in main run ☐ No apparent leaks

Attachment ☒ Loose ☐ Missing spikes ☐ Improperly sloped ☐ Satisfactory

Gutters leaking at joints recommend repair

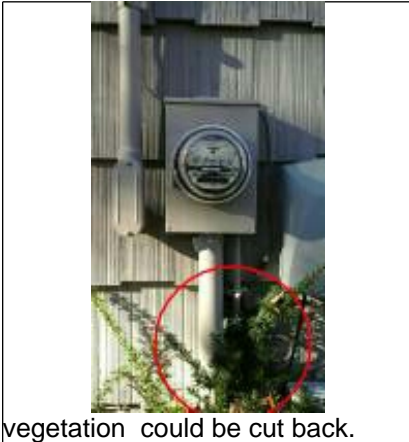
vegetation could be cut back.

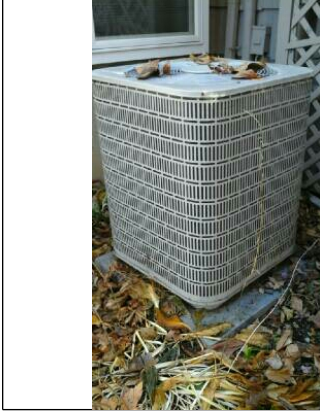
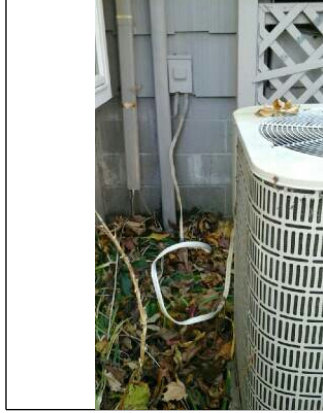
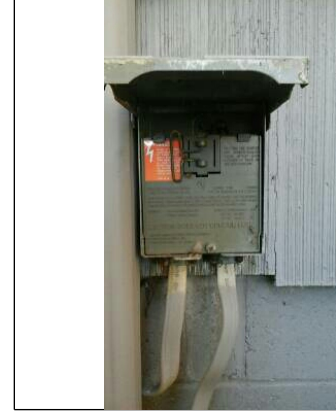
Comments Loose wires should be enclosed .

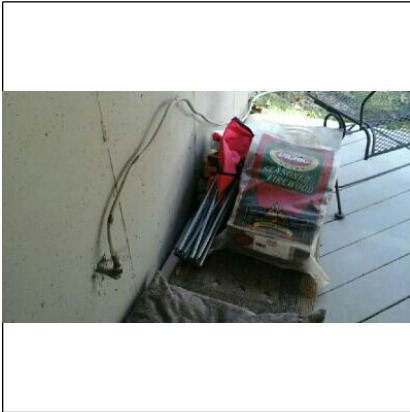
Comments Gas line coming in from outside must be in the ground and attached to house. Hole around pipe should be filled .

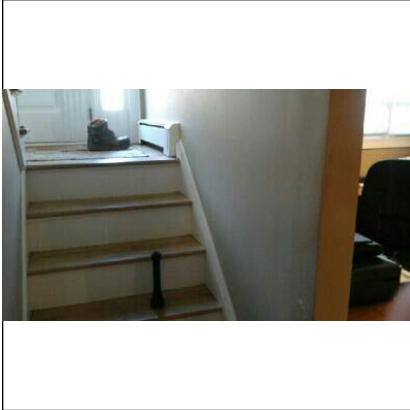
Comments Recommend handrail on lower staircase.

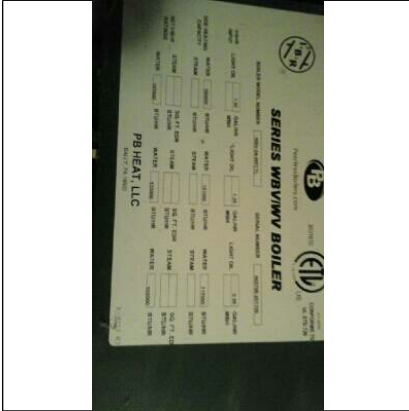
Comments Recommend a fan in the can to bring in combustion air.

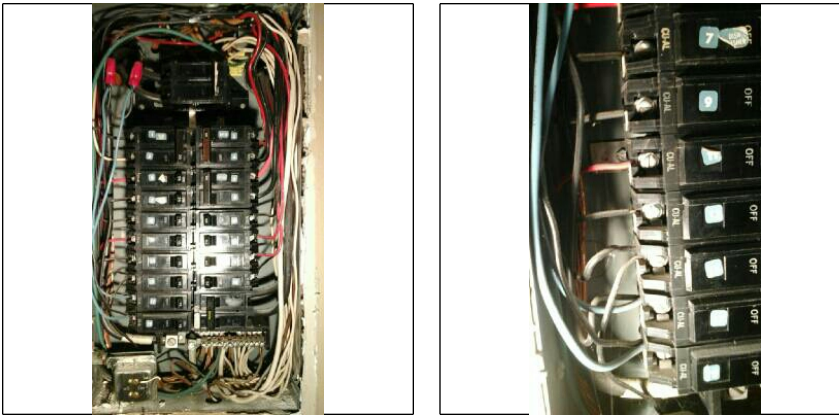
Comments Double tap on a 15 amp breaker
