Property Inspection Report

David R Lamp HOI.0000863
First Inspect Home Inspections LLC.

Sample
Inspection Prepared For: Sample
Agent:

Date of Inspection: 4/1/2025
Year Built: Size: 6560
Weather: Partly 45

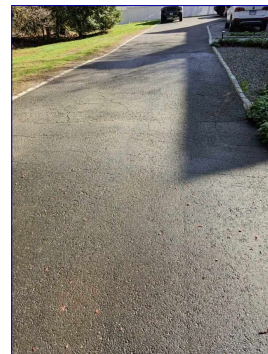
2. Driveway/Parking

- The driveway/parking material is asphalt. Asphalt should be kept sealed and larger cracks filled to prevent frost damage. Consult a professional contractor as needed. Cracks were observed at the driveway.

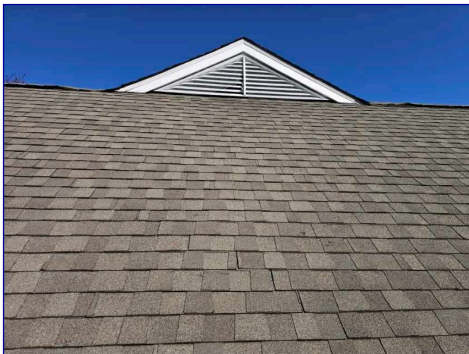
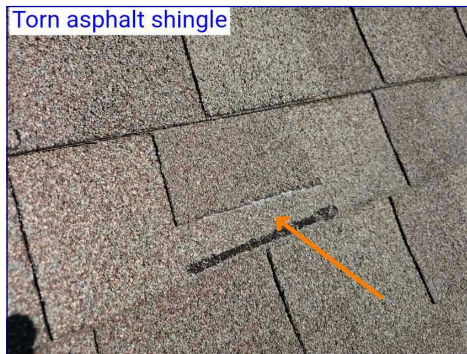
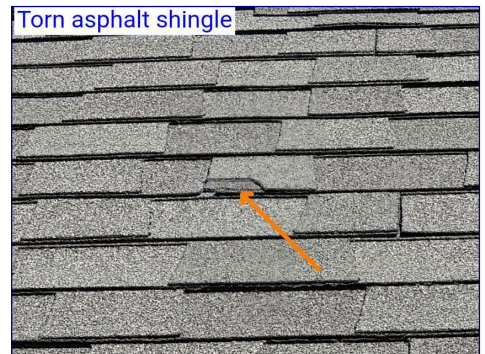
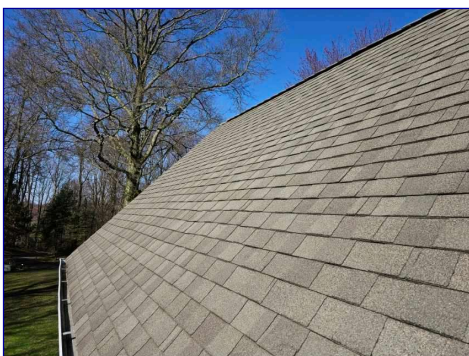
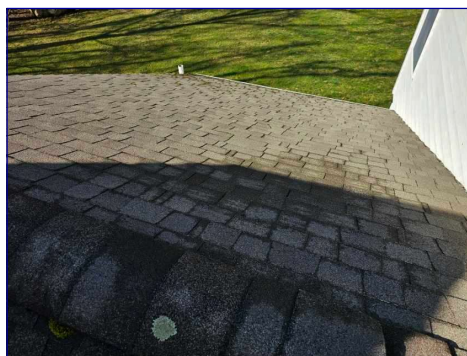
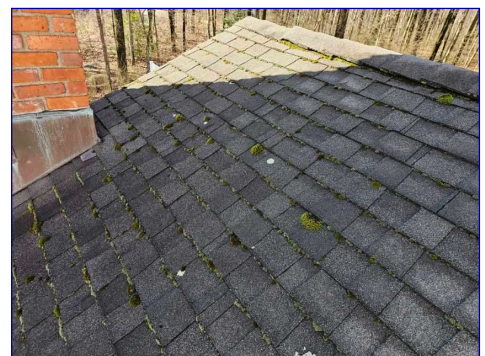
7. Condition of Roof Covering

- The roof has some moss and lichen growth. Recommend a soft wash to remove.
- The roof has some torn asphalt shingles. Have a licensed roofing contractor evaluate the roof and repair as needed.
- The roof is dated midlife to older. The average life expectancy of an architectural roof is 25 to 30 years, with maintenance.

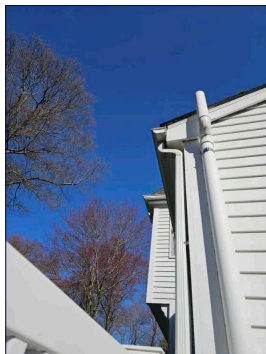
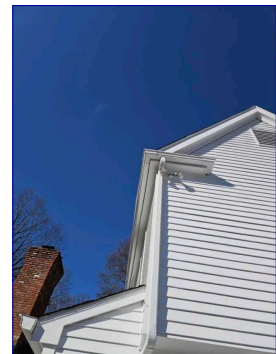
2. Gutters

- One or more gutter sections were loose with detached brackets and dents. Recommend a professional contractor repair.
- Some gutter downspouts terminate on roof surfaces, which is a common practice but will concentrate a large amount of water on one location of asphalt shingles. This will allow more wear in one location. Recommend redirecting the water discharge to other gutters or to the ground.

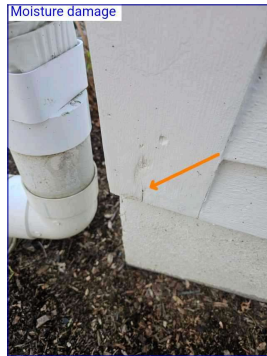
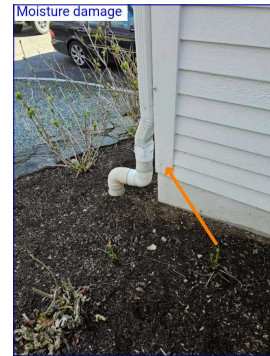
4. Trim

• Some of the wood trim had moisture damage at the lower right side of the garage. Recommend repair or replacement of damaged exterior trim.

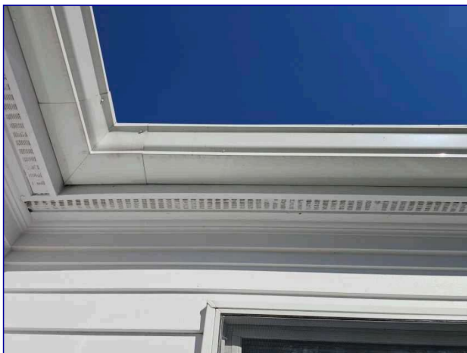
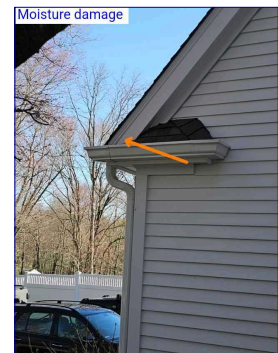
6. Fascia

- The wood fascia had some minor damage at the right side of the garage. Recommend repair.

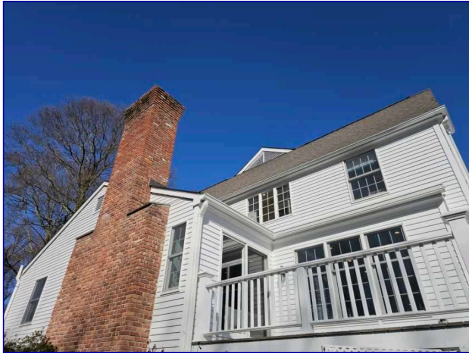
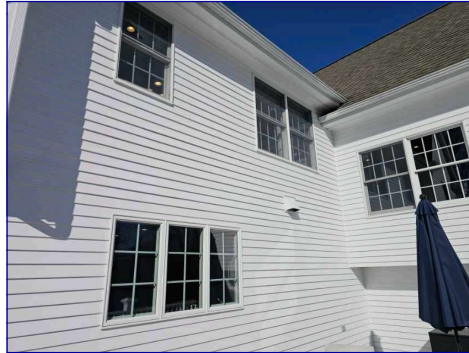
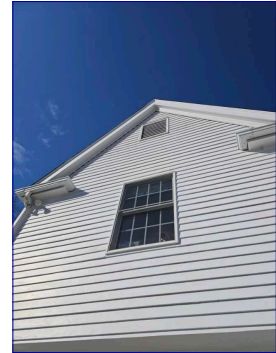
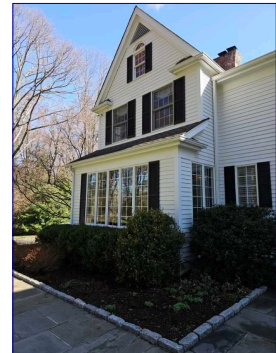
9. Windows/Screens

- Some window screens are torn or missing. Repair as needed.

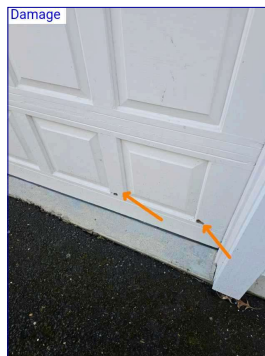
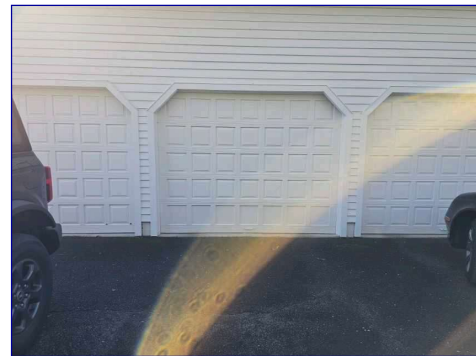
11. Overhead Door(s)

- Observations:
- The left garage door was damaged but was operable. Repair the damaged door as needed.

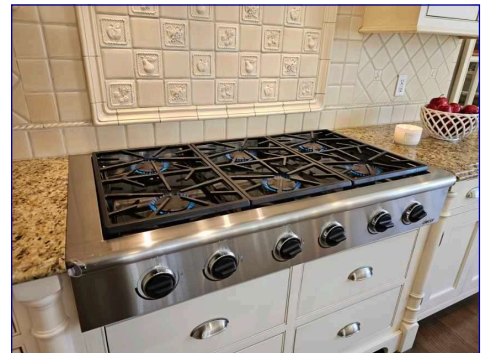
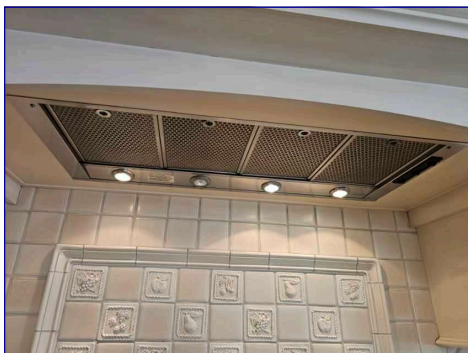
9. Appliances

- The lower oven door does not seal well. Repair as needed. Recommend an appliance technician evaluate.

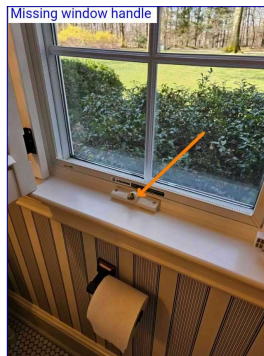
- The 1st floor half bathroom casement window has a missing handle. Repair as needed.

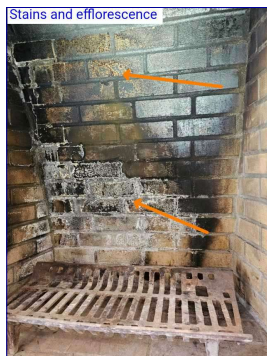
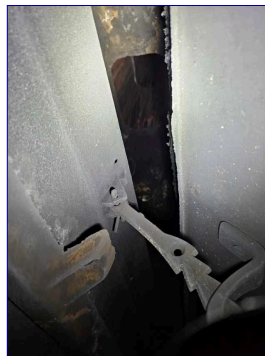
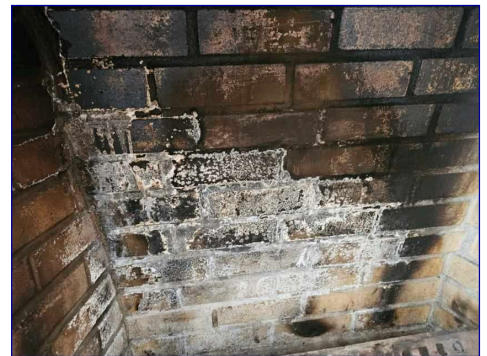
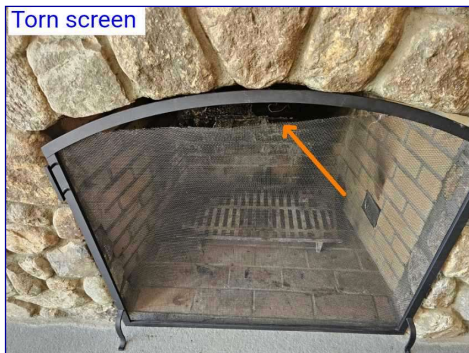
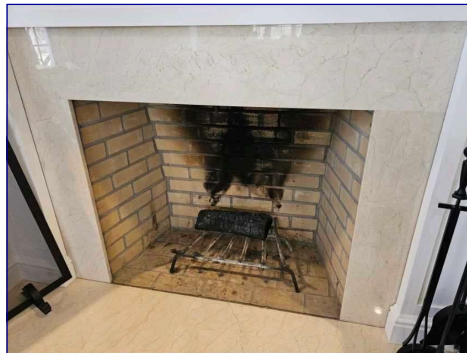
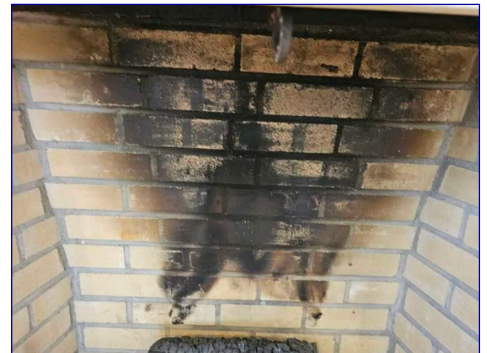
- The living room and family room fireplace firebrick has stains and efflorescence. Repair as needed.
- The living room fireplace screen is torn. Repair or replace as needed.

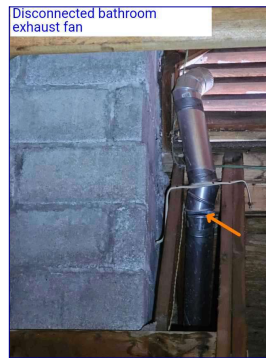
• Bathroom vents terminate in the attic. The vent is disconnected. Recommend repair to control moisture in the attic.

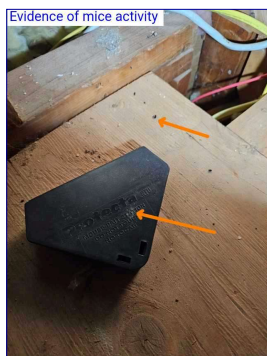
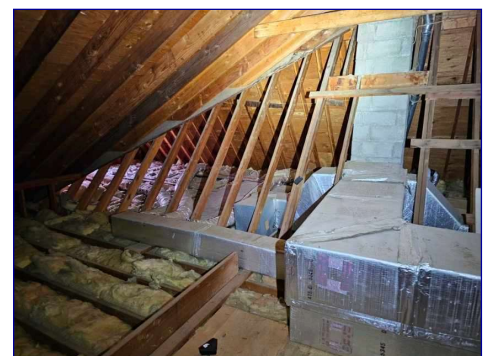
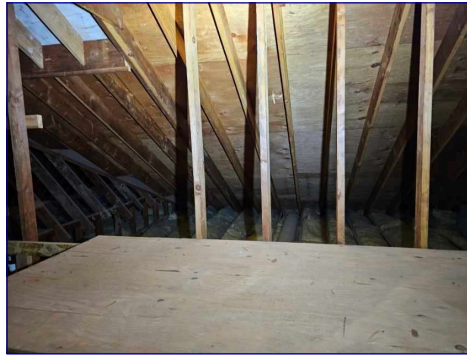
- Pests are not part of the home inspection. However, there is evidence of mice feces in the attic, basement, and garage, which is a safety concern. Recommend setting traps or have a professional exterminator evaluate and treat as needed.

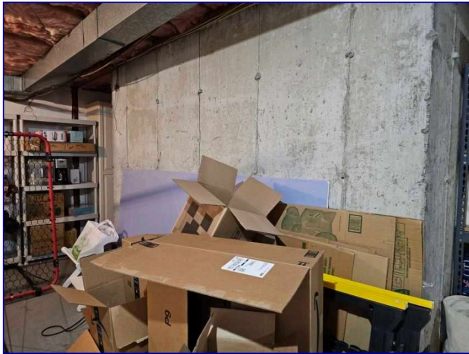
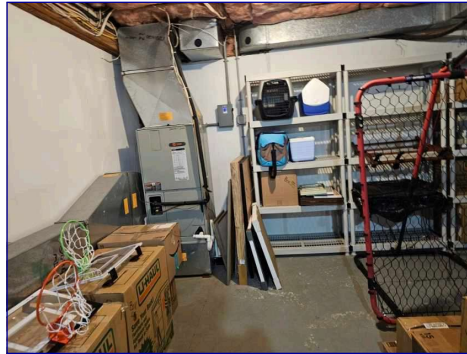
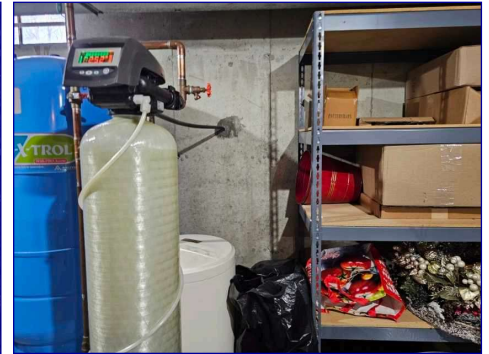
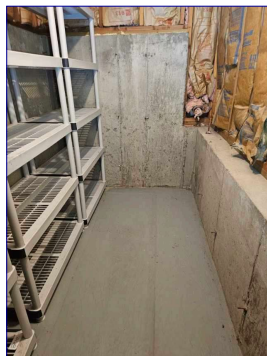
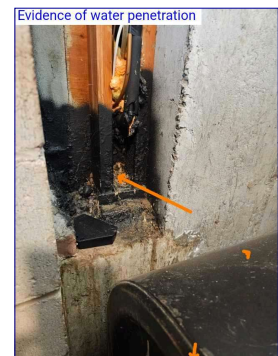
1. Foundation

- Foundation walls were covered with paneling/drywall/insulation/storage and were not visible. It is always possible that hidden damage may exist in non-visible areas. Consult a licensed contractor as needed.
- Evidence of water penetration was observed behind the furnace above the foundation where the A/C compressor condenser lines enter the house. Recommend monitoring water activity and contacting a licensed basement waterproofing company as needed.

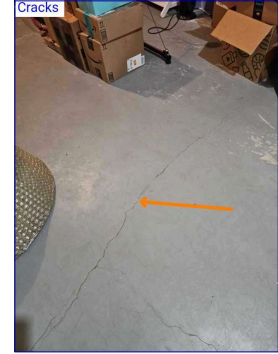
2. Basement Floor

- The basement floor has typical cracks. Monitor and consult a licensed contractor if the cracks become active.

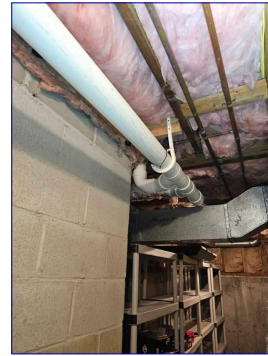
• The waste drain for the home is a septic-type system. Repair and maintenance are the homeowner's responsibility. Recommend a septic service professional pump and inspect the septic system before closing. (EPA INFORMATION- The average household septic system should be inspected at least every three years by a septic system professional. Household septic tanks are typically pumped every 3-5 years, according to the EPA. Systems that have mechanical parts like float switches, pumps, or alarms should be inspected annually.)

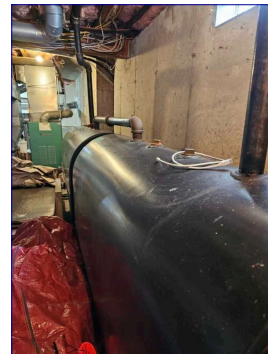
- Evidence of an underground oil tank was observed in the basement. Recommend contacting the town of Wilton to determine if it was removed with documentation on file.

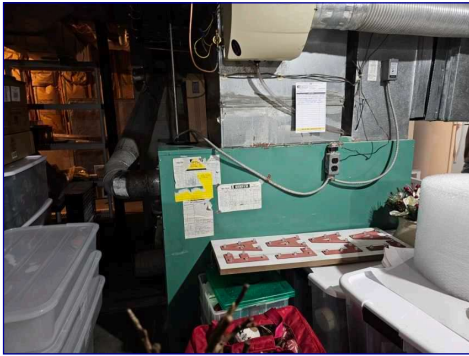
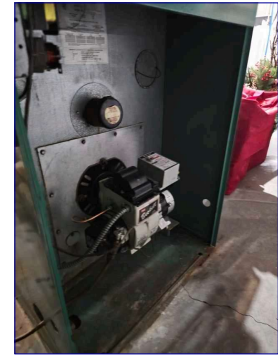
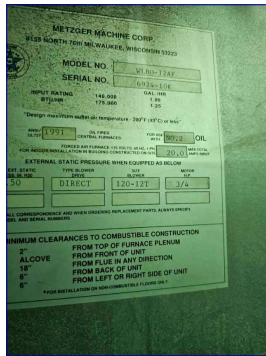
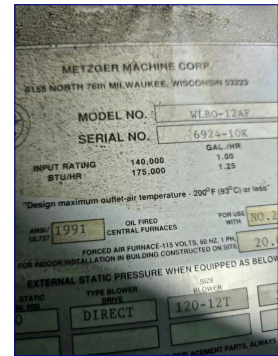
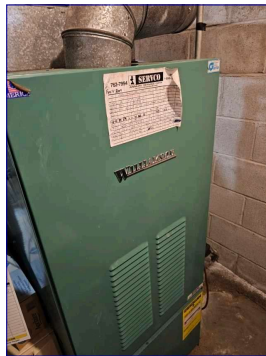
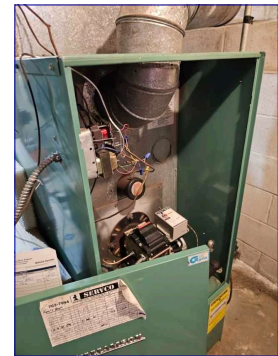
- The Williamson furnaces appear to be dated mid to late 1990s early 2000s. The average life expectancy of a furnace is 15 to 20 years, with maintenance. Recommend purchasing a service contract and have annual maintenance to extend its life. Recommend budgeting for repairs or replacement based on its age.

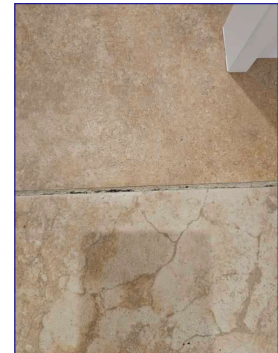
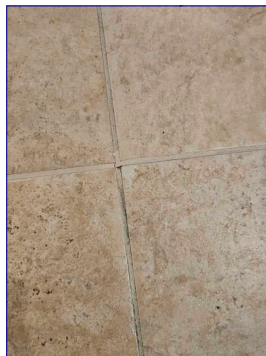
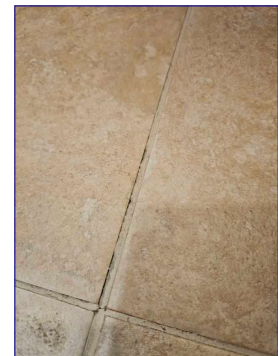
- The first floor tile floor throughout the laundry room, bathroom, and hallway has loose and cracked grout. Recommend repair and monitoring for tile detachment.
