Home Inspection Report

5 Key West Dr, Danbury , CT 06811

Inspection Date:

Tuesday September 29, 2015

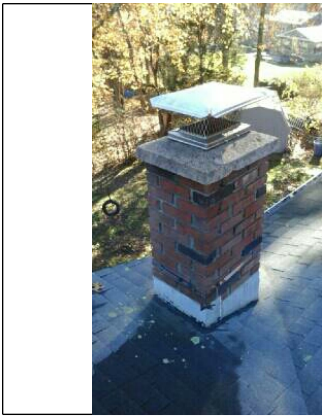
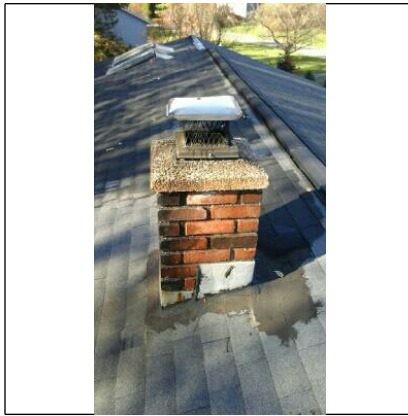
Roof is patched around chimney and skylights and missing shakes. Will need a new roof in the near future.

Roof #1 ☐ Satisfactory ☒ Marginal ☐ Poor ☐ Curling ☐ Cracking ☐ Ponding ☐ Burn Spots
☒ Broken/Loose Tiles/Shingles ☐ Nail popping ☒ Granules missing ☐ Alligating ☐ Blistering
☒ Missing Tabs/Shingles/Tiles ☐ Moss buildup ☐ Exposed felt ☐ Cupping
☐ Incomplete/Improper Nailing ☒ Recommend roofer evaluate ☐ Evidence of Leakage
Roof #2 ☐ N/A ☐ Satisfactory ☐ Marginal ☐ Poor ☐ Curling ☐ Cracking ☐ Ponding ☐ Burn Spots
☐ Broken/Loose Tiles/Shingles ☐ Nail popping ☐ Granules missing ☐ Alligating ☐ Blistering
☐ Missing Tabs/Shingles/Tiles ☐ Moss buildup ☐ Exposed felt ☐ Cupping
☐ Incomplete/Improper Nailing ☐ Recommend roofer evaluate ☐ Evidence of Leakage
Roof #3 ☐ N/A ☐ Satisfactory ☐ Marginal ☐ Poor ☐ Curling ☐ Cracking ☐ Ponding ☐ Burn Spots
☐ Broken/Loose Tiles/Shingles ☐ Nail popping ☐ Granules missing ☐ Alligating ☐ Blistering
☐ Missing Tabs/Shingles/Tiles ☐ Moss buildup ☐ Exposed felt ☐ Cupping
☐ Incomplete/Improper Nailing ☐ Recommend roofer evaluate ☐ Evidence of Leakage

Roof is in need of replacement
