Property Inspection Report

David R Lamp HOI.0000863
First Inspect Home Inspections LLC.

Sample
Inspection Prepared For: Sample
Agent:

Date of Inspection: 4/1/2025
Year Built: Size: 6560
Weather: Partly 45

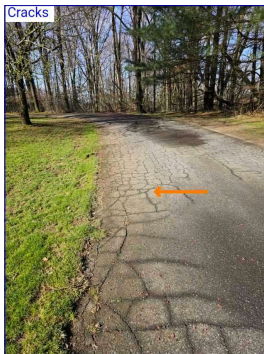
2. Driveway/Parking

- The driveway/parking material is asphalt. Asphalt should be kept sealed and larger cracks filled to prevent frost damage. Consult a professional contractor as needed. Cracks were observed at the driveway.

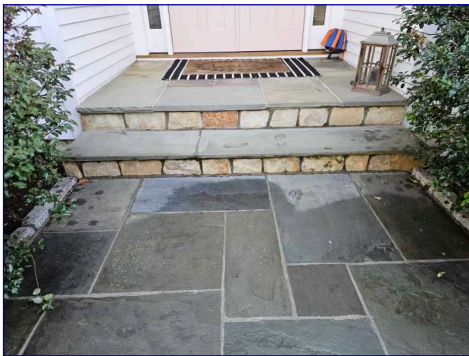
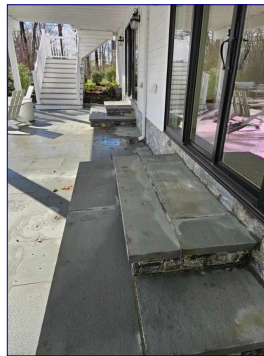
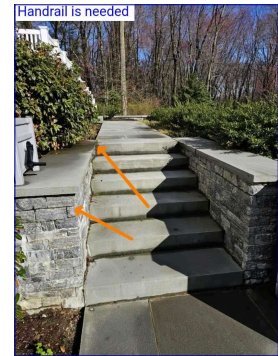
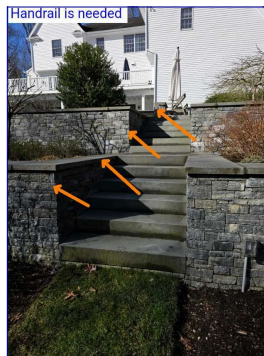
3. Porch

- The back stone steps need handrails installed for added safety.

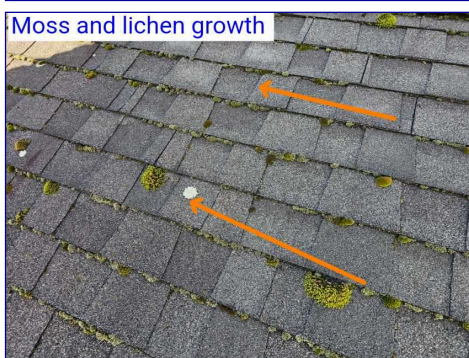
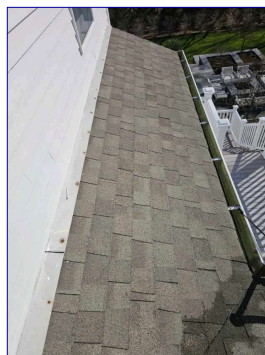
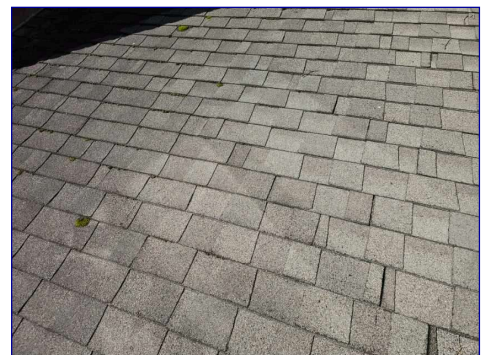
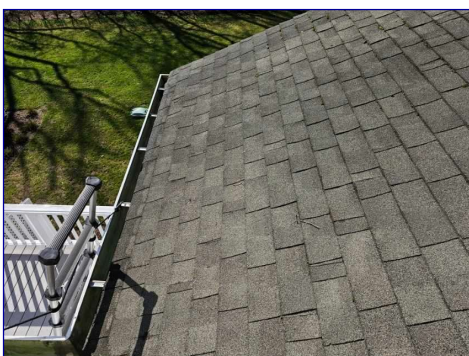
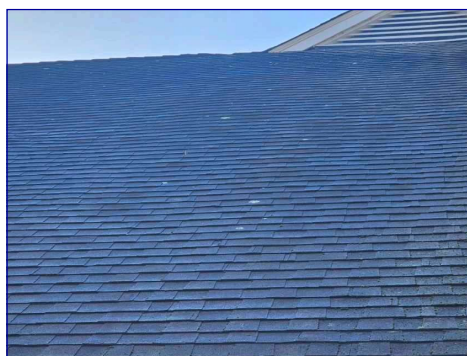
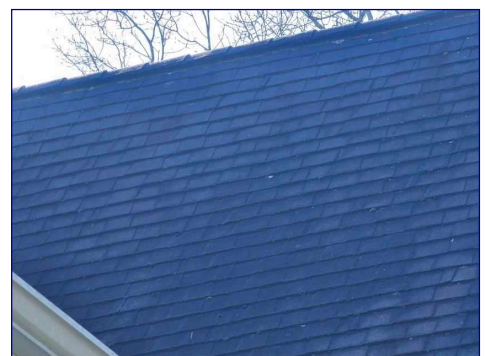
7. Condition of Roof Covering

- The roof has some moss and lichen growth. Recommend a soft wash to remove.
- The roof has some torn asphalt shingles. Have a licensed roofing contractor evaluate the roof and repair as needed.
- The roof is dated midlife to older. The average life expectancy of an architectural roof is 25 to 30 years, with maintenance.

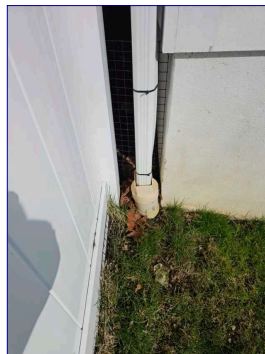
2. Gutters

- Attachment: Loose
- Attachment: Missing/Loose spikes

- One or more gutter sections were loose with detached brackets and dents. Recommend a professional contractor repair.
- Some gutter downspouts terminate on roof surfaces, which is a common practice but will concentrate a large amount of water on one location of asphalt shingles. This will allow more wear in one location. Recommend redirecting the water discharge to other gutters or to the ground.

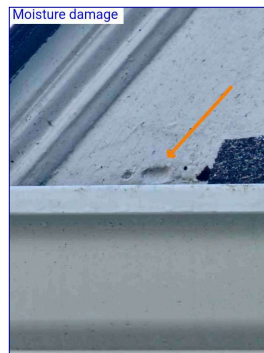
- Damaged wood

- The wood fascia had some minor damage at the right side of the garage. Recommend repair.

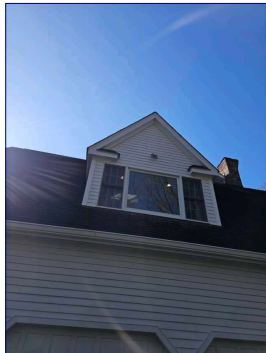
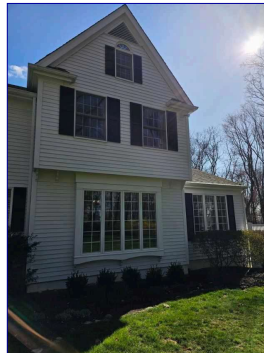
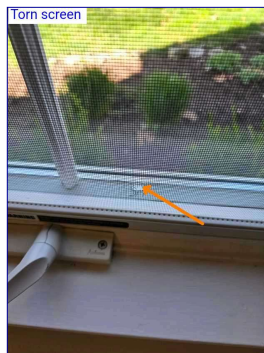
- Some window screens are torn or missing. Repair as needed.

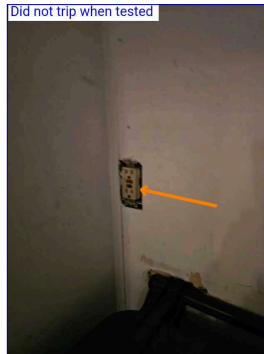
- There is at least one cover plate missing at a receptacle in the garage. This is a safety concern. Recommend a licensed electrician install a cover plate.
- The garage GFI receptacle was not operating properly, and it won't trip when tested. This is a safety concern. Recommend a licensed electrician repair.

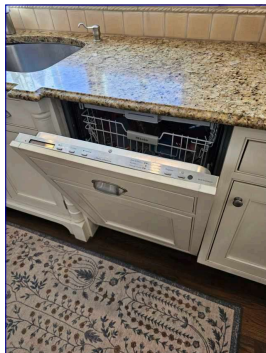
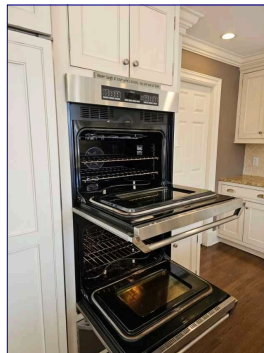
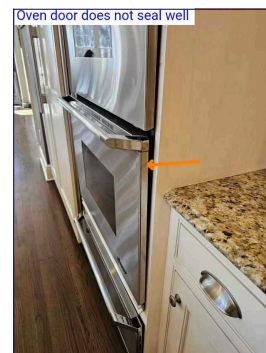
- The lower oven door does not seal well. Repair as needed. Recommend an appliance technician evaluate.

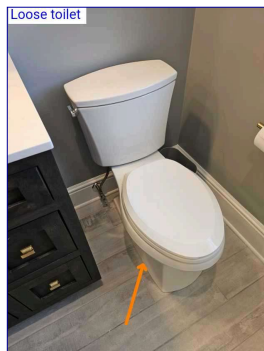
- Bowl loose: Yes
 - Operable: Yes
- Observations:

• The toilet bowl is loose in the 2nd floor shared bathroom. Since the movement of the toilet will damage the wax ring, recommend replacing the wax ring. While the toilet is removed, verify that the subfloor is still in good condition. Repair as needed.

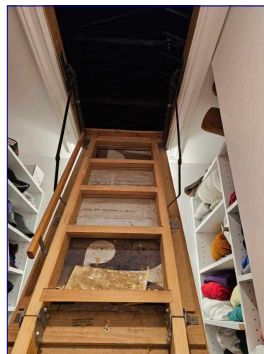
- The attic pull-down stairs have weak springs. The door needs to be pushed up to seal. Recommend repair.

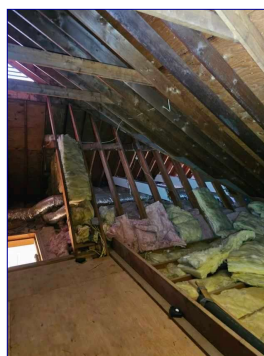
- Pests are not part of the home inspection. However, there is evidence of mice feces in the attic, basement, and garage, which is a safety concern. Recommend setting traps or have a professional exterminator evaluate and treat as needed.

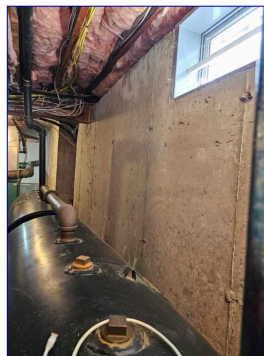
1. Foundation

- Foundation walls were covered with paneling/drywall/insulation/storage and were not visible. It is always possible that hidden damage may exist in non-visible areas. Consult a licensed contractor as needed.
- Evidence of water penetration was observed behind the furnace above the foundation where the A/C compressor condenser lines enter the house. Recommend monitoring water activity and contacting a licensed basement waterproofing company as needed.

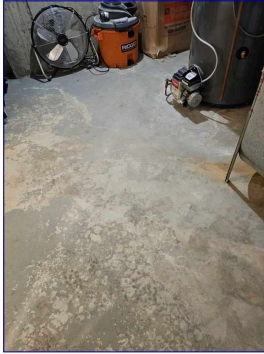
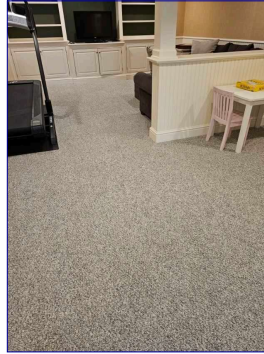
- The basement floor has typical cracks. Monitor and consult a licensed contractor if the cracks become active.

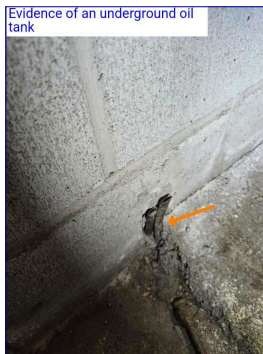
- Evidence of an underground oil tank was observed in the basement. Recommend contacting the town of Wilton to determine if it was removed with documentation on file.

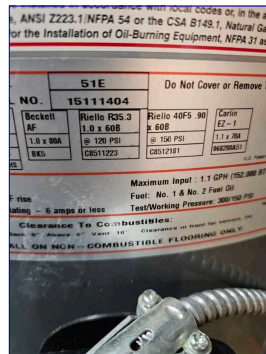
- The water heater is dated 2015. The average life expectancy of a water heater is 8 to 12 years.

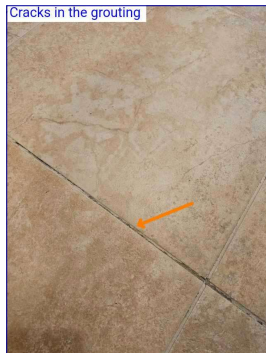
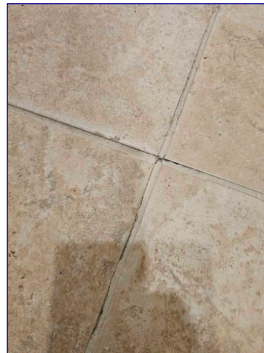
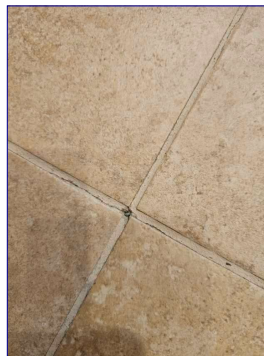
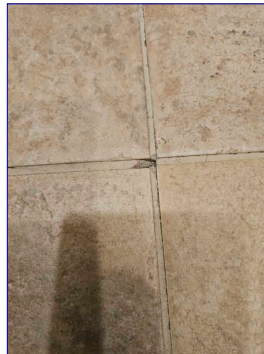
- The first floor tile floor throughout the laundry room, bathroom, and hallway has loose and cracked grout. Recommend repair and monitoring for tile detachment.
